SFPUC Alameda Creek Watershed Confluence (Grazing Unit 15) Alameda County, California

Hetch Hetchy
Regional Water System
Services of the San Francisco Public Utilities Commission

February 3, 2026

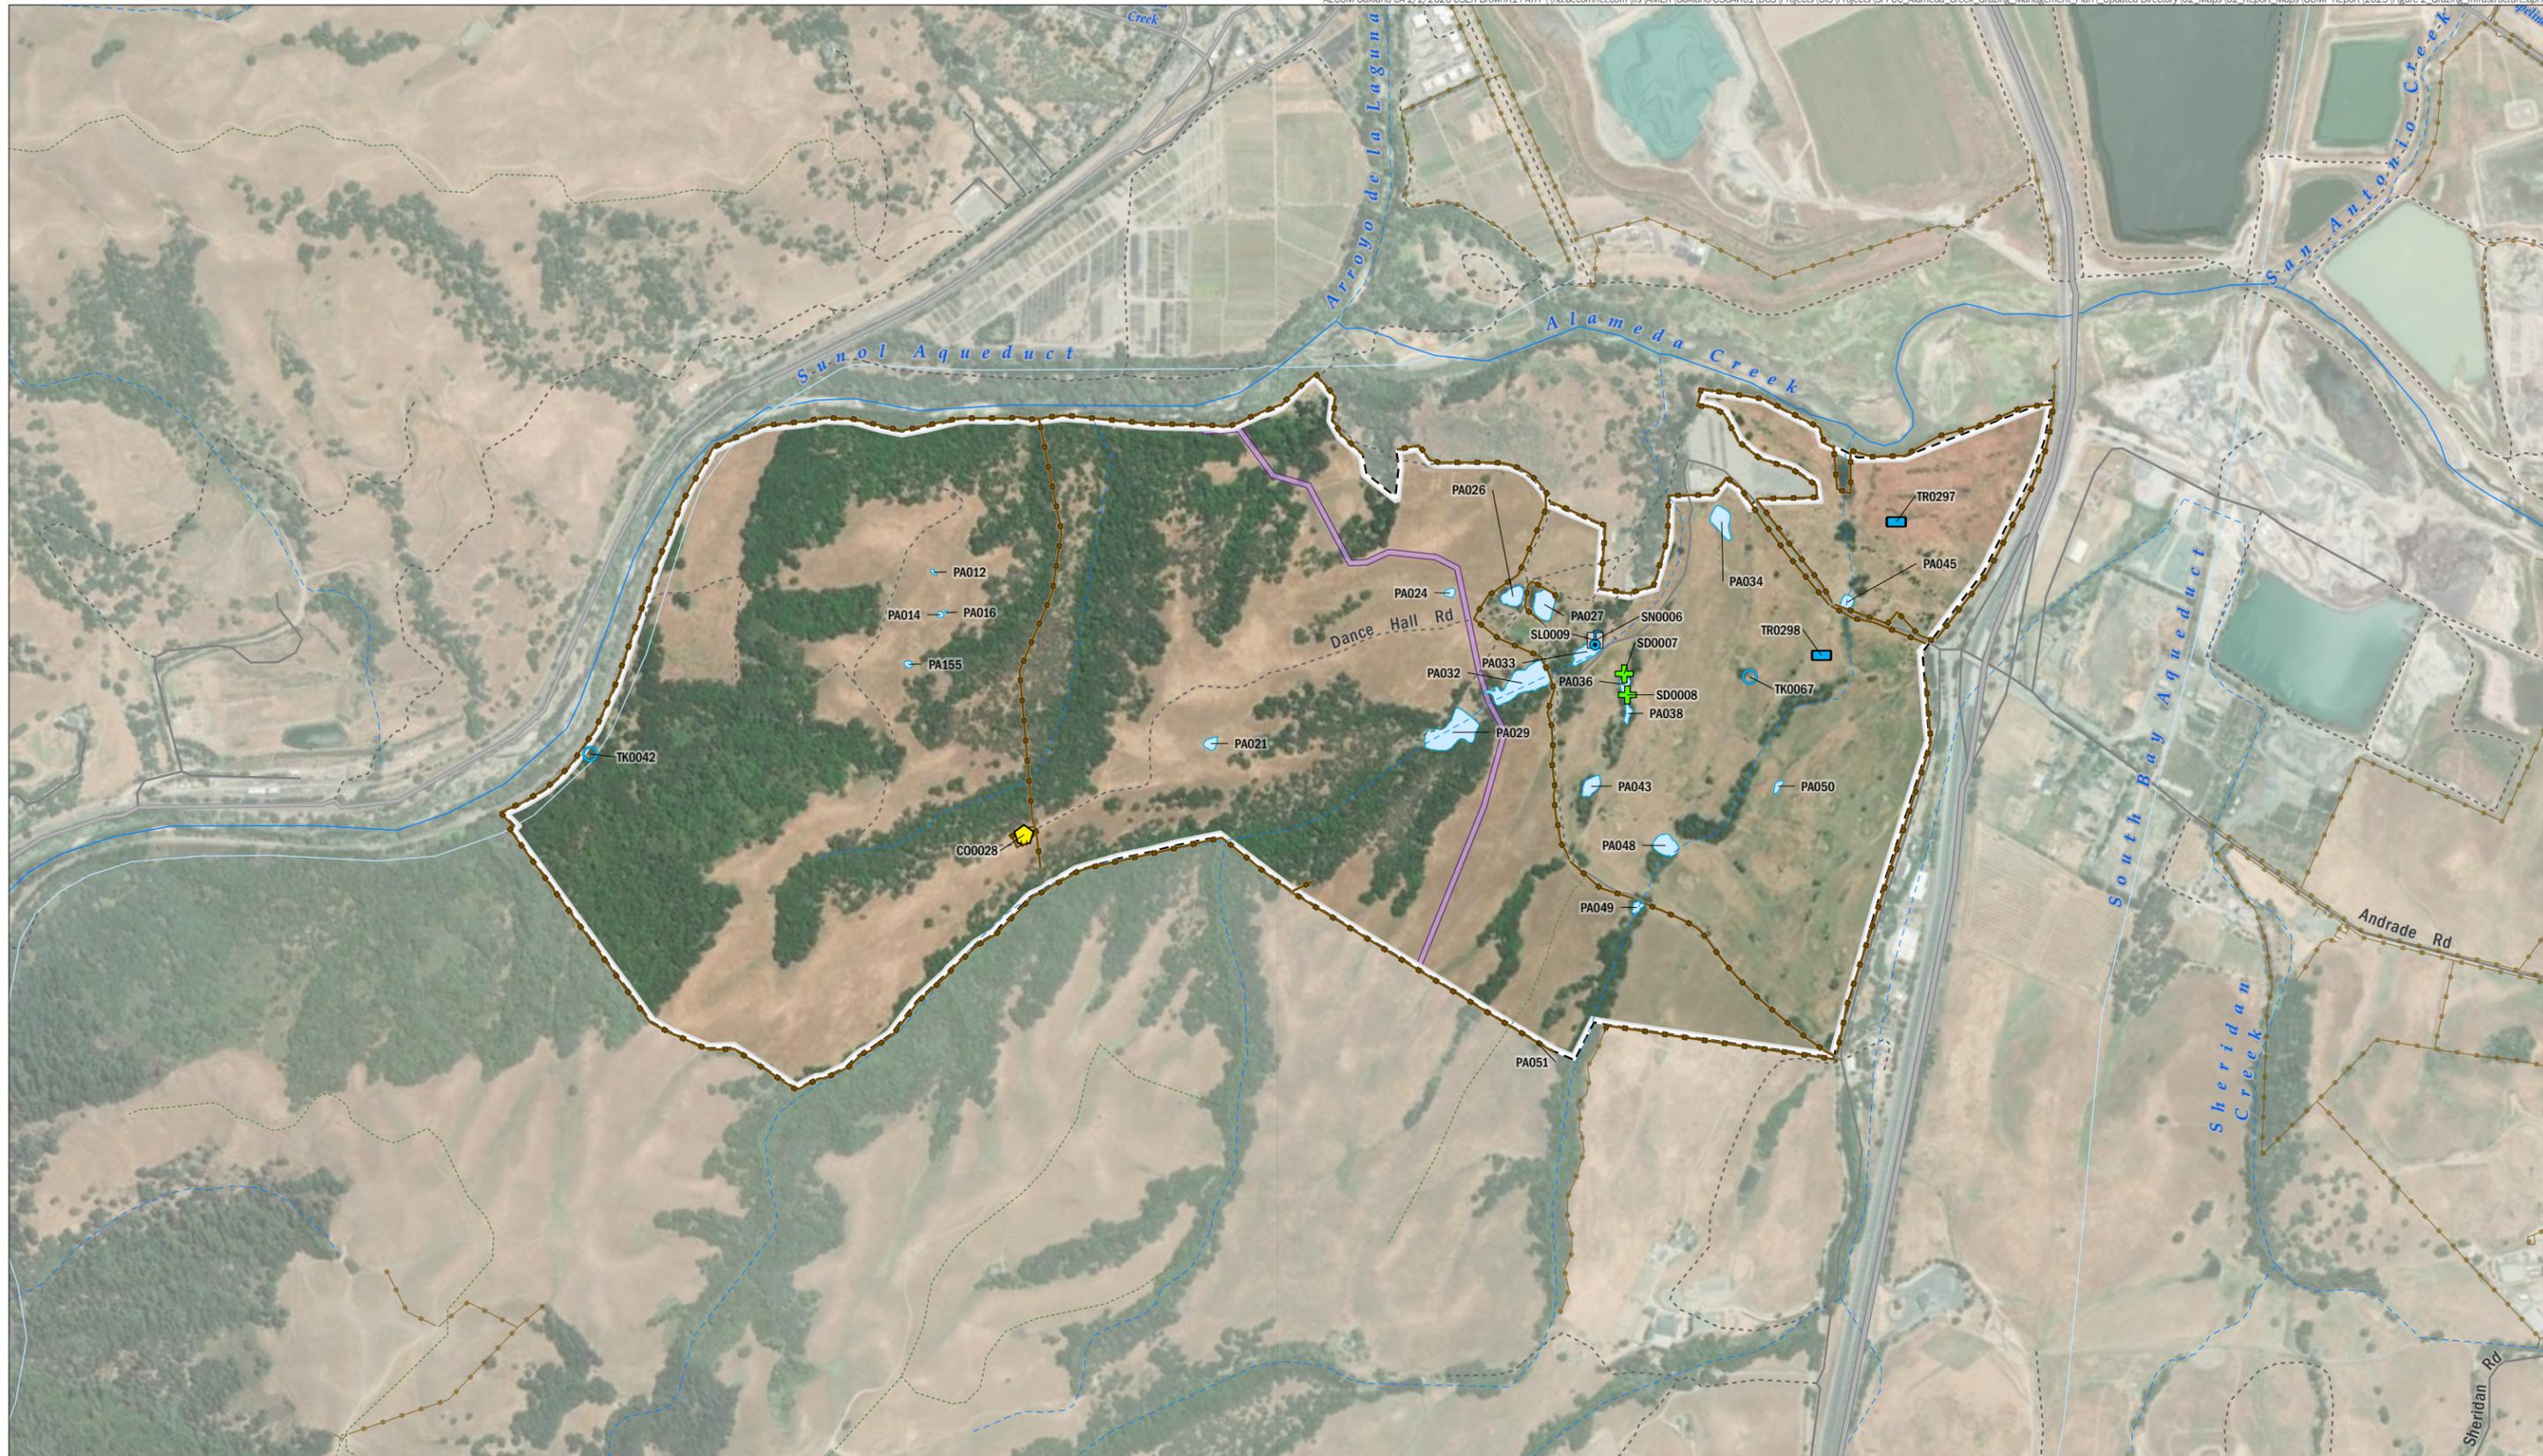
Figure 2: GRAZING UNIT 15 CONFLUENCE

- Grazing Infrastructure**
- Corral
 - Solar Panel
 - Solar Pump
 - Stream Diversion
- Confluence (GU-15): Corral C00028 is tenant-owned.

A detailed grazing infrastructure survey of the watershed was conducted from 2013 to 2015, with an additional survey conducted in 2022 for the added parcels (Figure 2). Staff updated infrastructure data in 2025. The number, condition, and location of various types of infrastructure such as barns, corrals, springs, and troughs were assessed and are summarized in this section. This section of the also outlines recommendations for rangeland improvements.
