# SFPUC Alameda Creek Watershed Calaveras Reservoir (Grazing Unit 23) Alameda and Santa Clara Counties, California

Hetch Hetchy  
**Regional Water System**  
Services of the San Francisco Public Utilities Commission

February 3, 2026

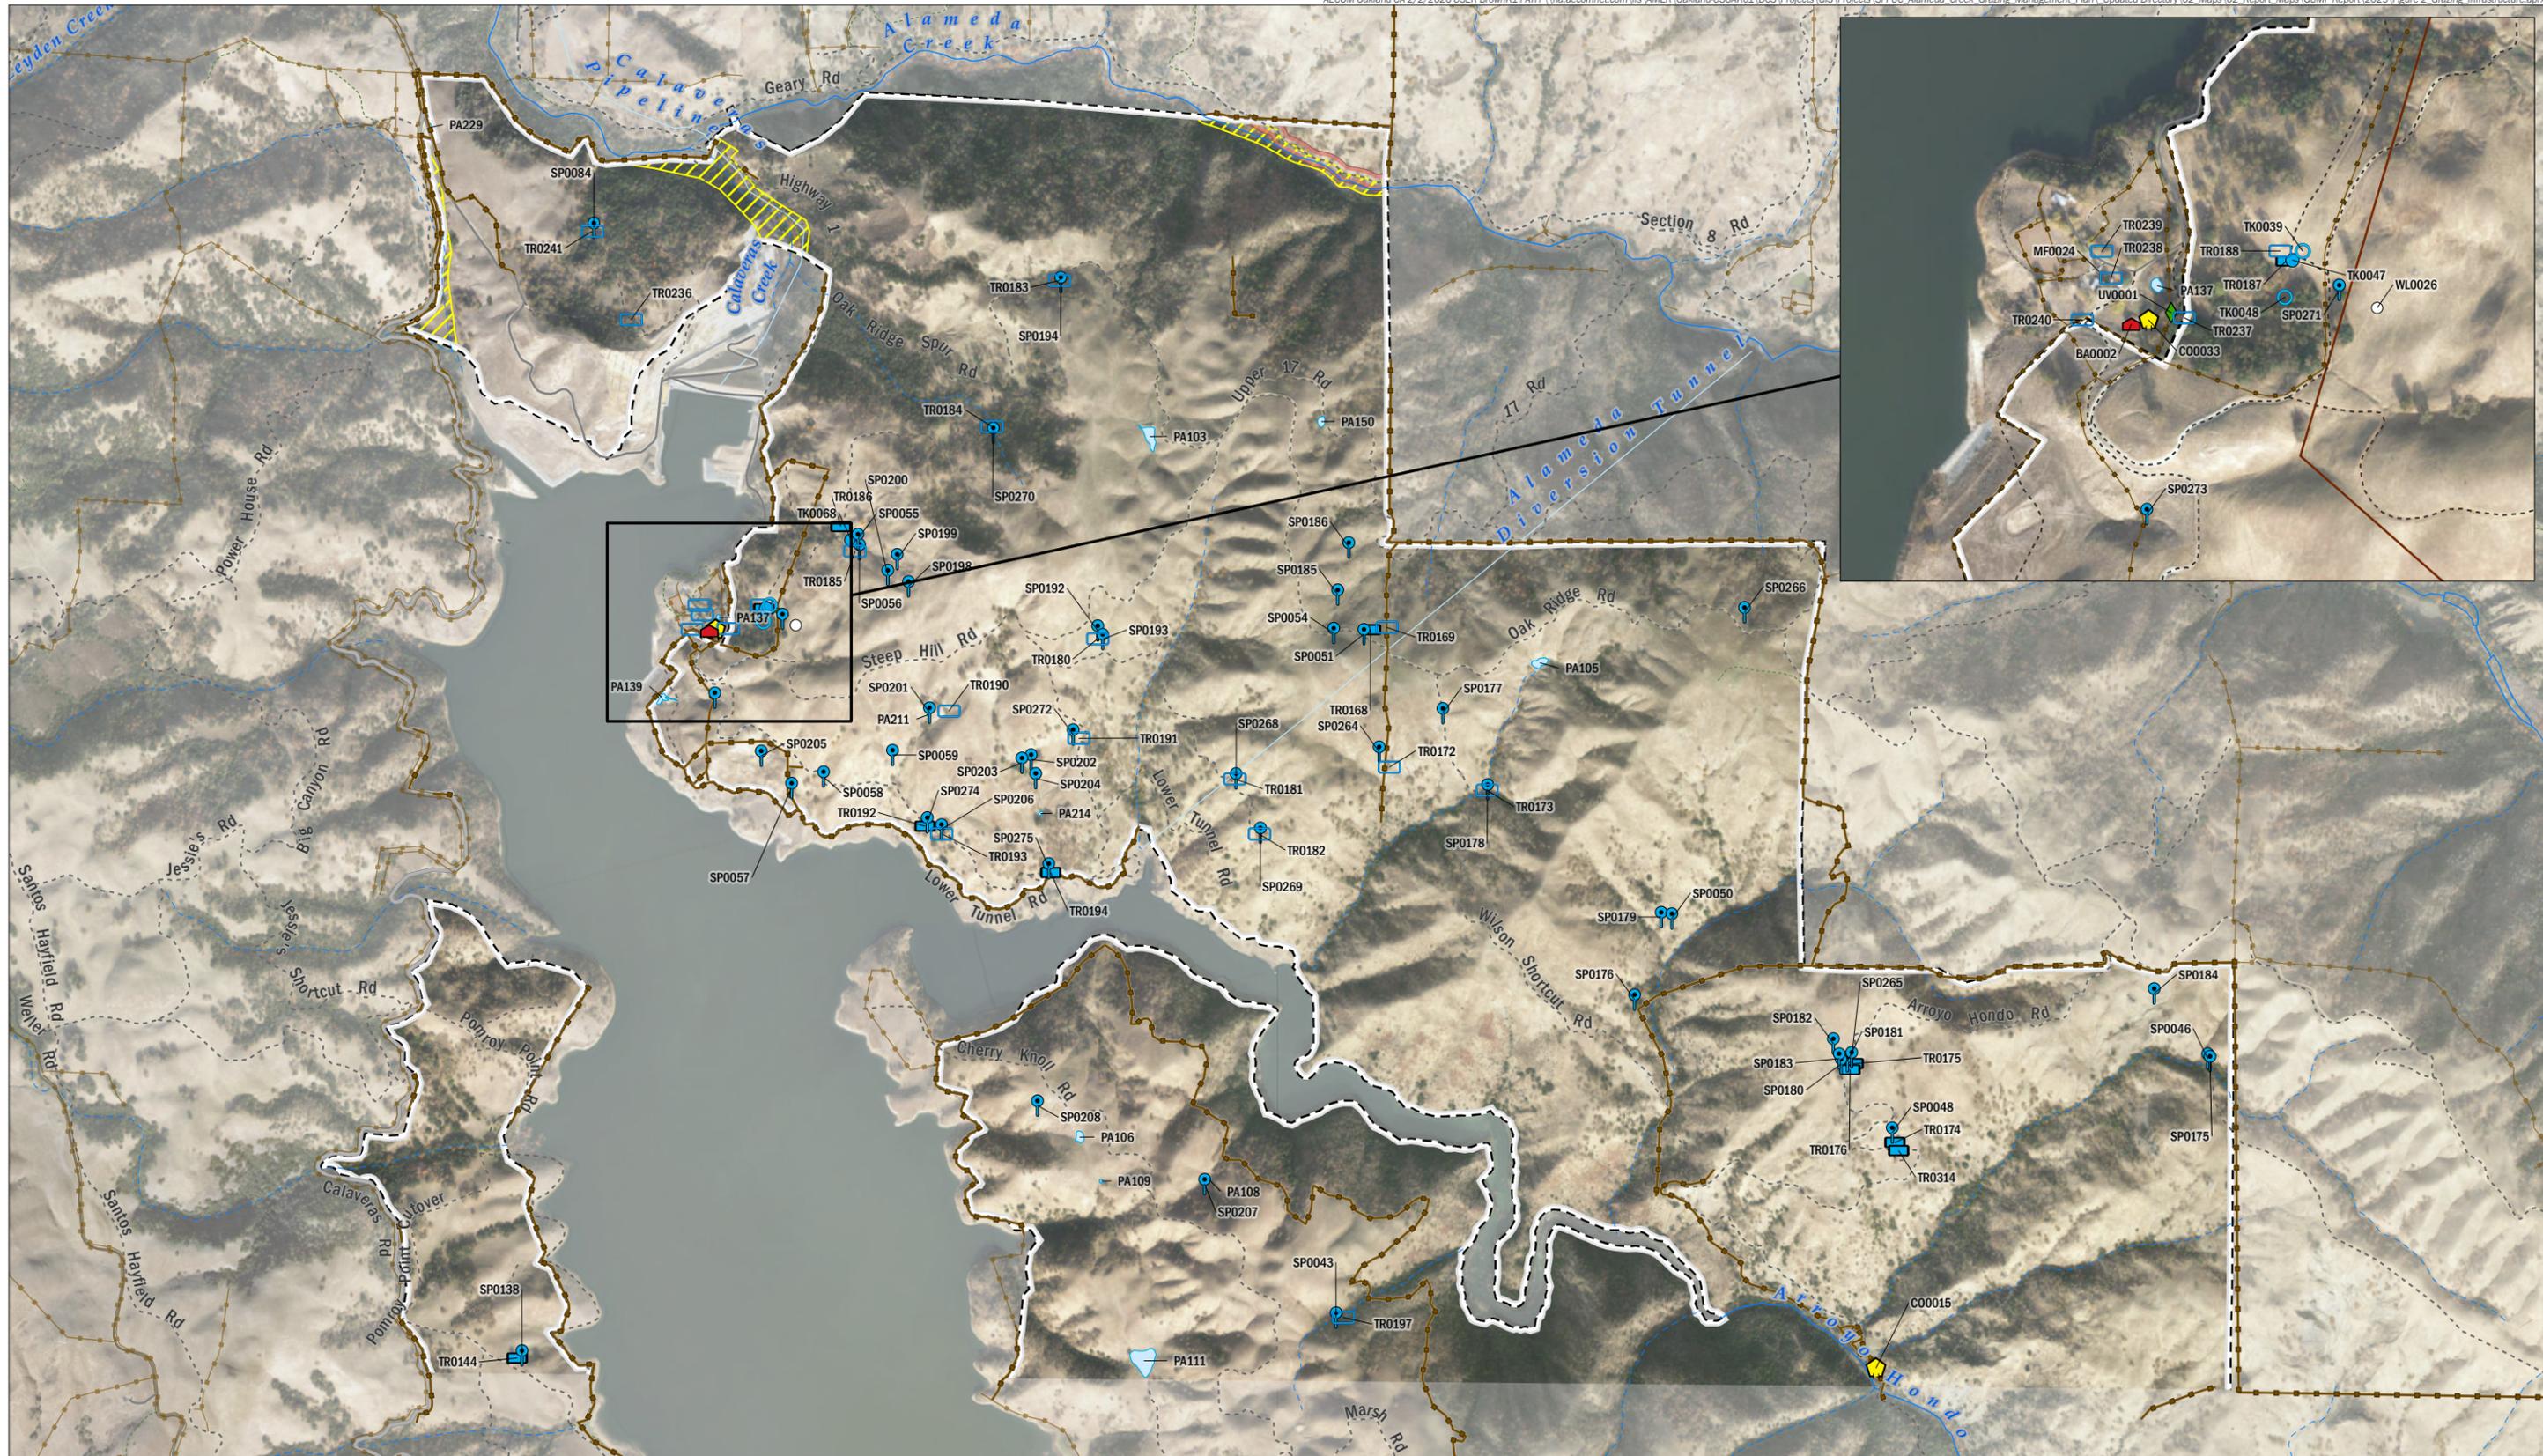
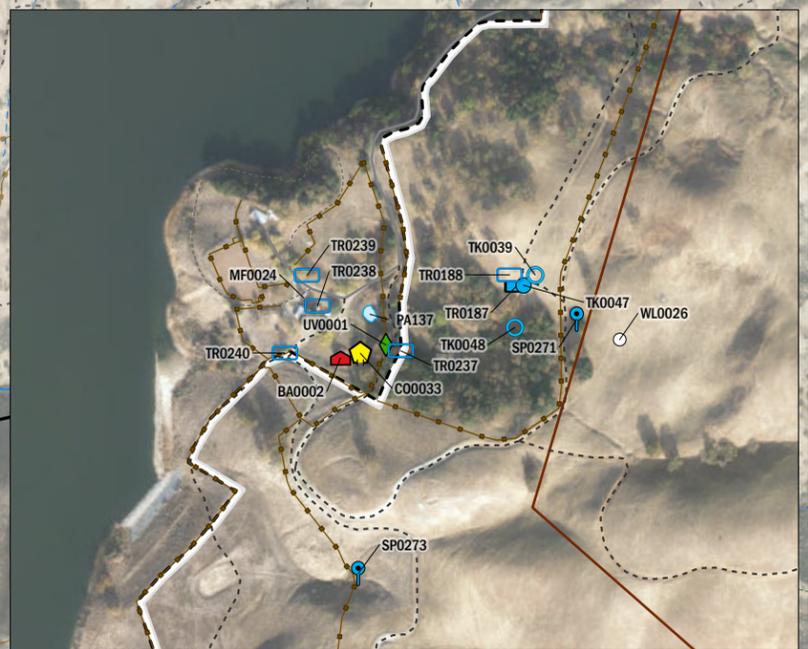
**Figure 2: GRAZING UNIT 23  
CALAVERAS RESERVOIR - PART 1**

A detailed grazing infrastructure survey of the watershed was conducted from 2013 to 2015 (Figure 2). This survey was updated by rangeland staff in 2025. The number, condition, and location of various types of infrastructure such as barns, corrals, springs, and troughs were assessed and are summarized in this section. This section of the GUMP also outlines recommendations for rangeland improvements.

Portions of the lease are Managed Riparian Areas and are subject to use and access restrictions. One Managed Riparian Area is associated with Calaveras Creek, as shown in Figure 2. Originally adopted in the 1997 Grazing Resources Management Plan and the 2001 Alameda WMP, Managed Riparian Areas are buffers around streams that are restricted from grazing to protect water quality for both habitat and source water protection. The SFPUC's Watershed Resources Manager may approve seasonal prescribed grazing in Managed Riparian Areas to protect the watershed and natural resources, for example to reduce wildfire risk, control NNIPs, and support special status species.
