Scenario 2: Sewer Back-Up From House Property Due to Blocked Lower Lateral.

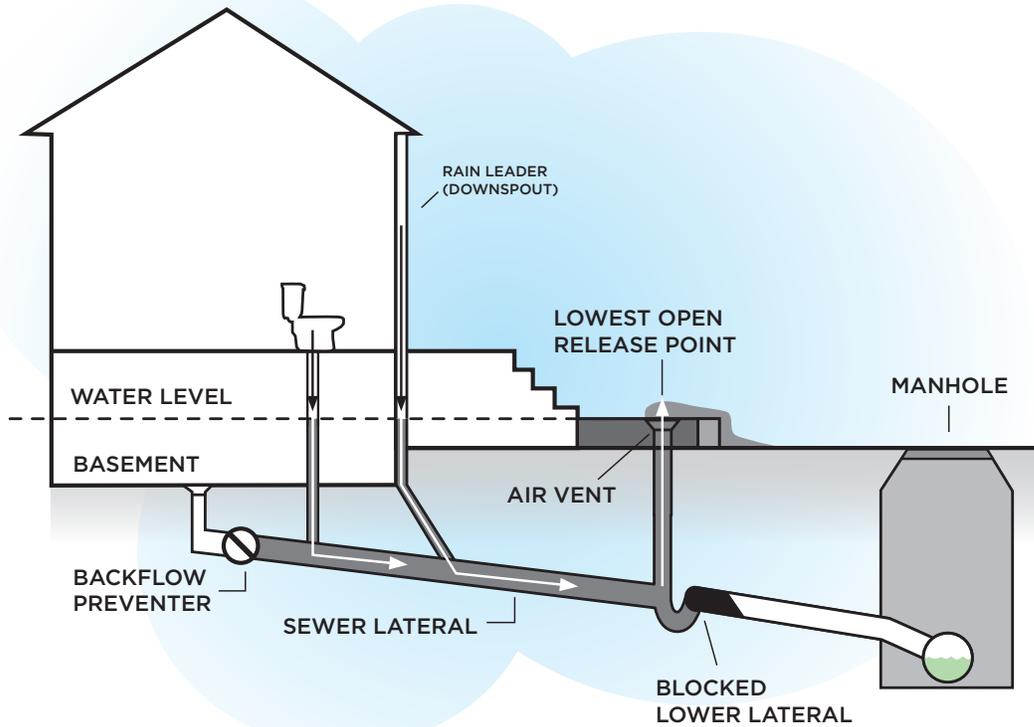
LATERAL WITH BACKFLOW PREVENTER

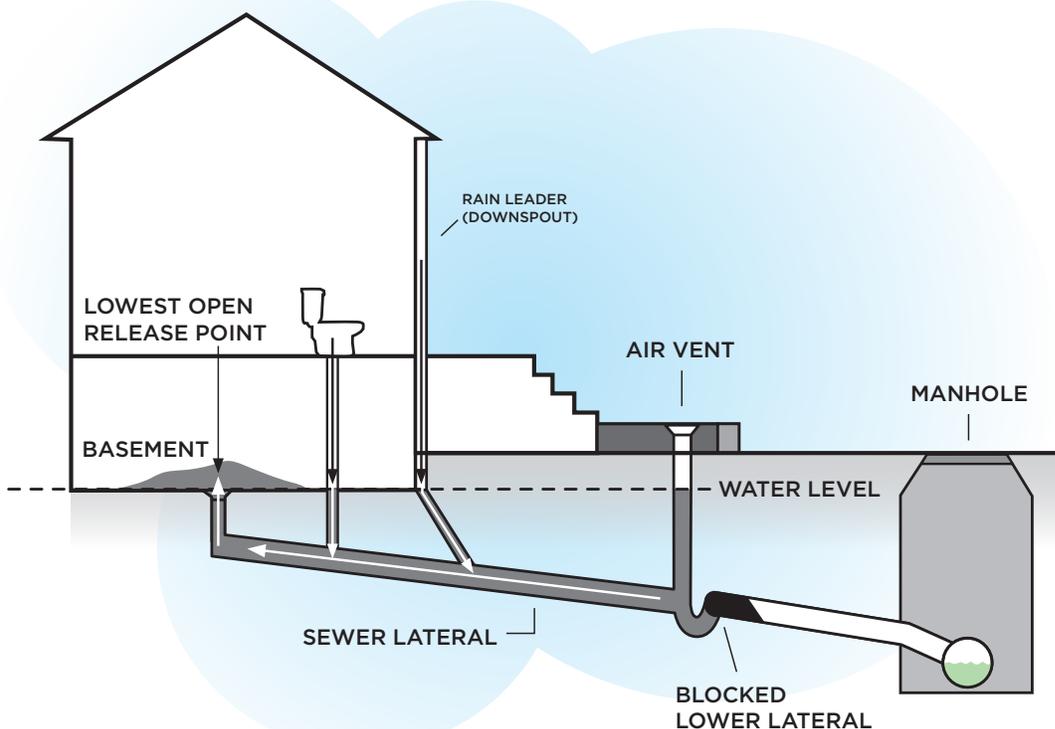
LATERALS MISSING BACKFLOW PREVENTER
